**NATIONAL REGISTER OF HISTORIC PLACES
REGISTRATION FORM**

historic name Russell House
other names/site number 380C106

1 OF 5
COLLEGE OF ARCHITECTURE
CLEMSON UNIVERSITY
CAAR 490, PROF. GEORGE FOLK

THE RUSSELL FARMSTEAD
MOUNTAIN REST, S.C. CA. 1867

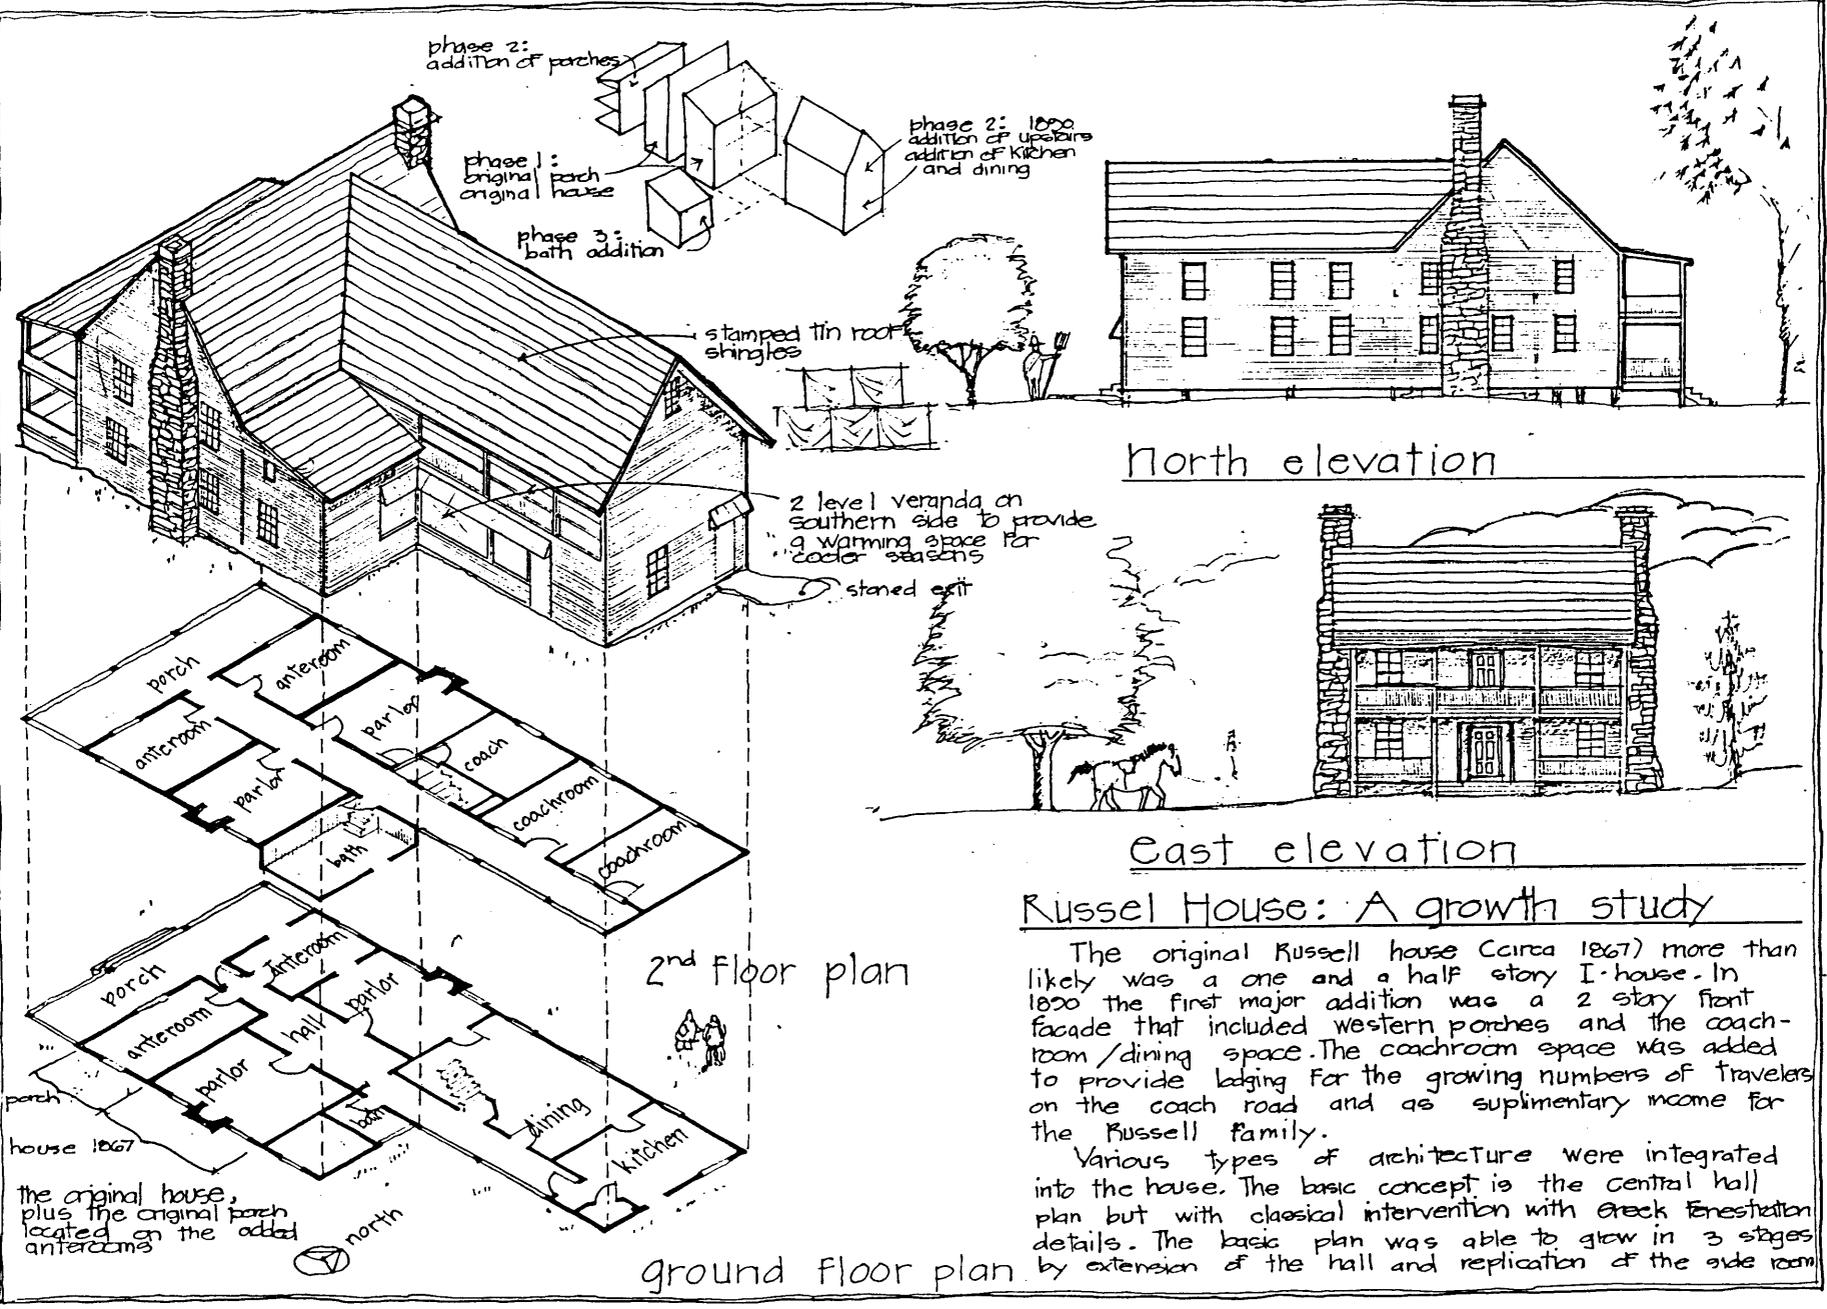
Russel House: A growth study

The original Russell house (circa 1867) more than likely was a one and a half story I-house. In 1890 the first major addition was a 2 story front facade that included western porches and the coach-room/dining space. The coachroom space was added to provide lodging for the growing numbers of travelers on the coach road and as supplementary income for the Russell family.

Various types of architecture were integrated into the house. The basic concept is the central hall plan but with classical intervention with Greek fenestration details. The basic plan was able to grow in 3 stages by extension of the hall and replication of the side room

the original house, plus the original porch located on the added anterooms

phase 2: addition of porches

phase 1: original house

phase 3: bath addition

phase 2: 1890 addition of upstairs addition of kitchen and dining

stamped tin roof shingles

2 level veranda on southern side to provide a warming space for cooler seasons

stoneed gable

The main house underwent considerable expansion, in several campaigns, in the late nineteenth and early twentieth centuries to arrive at its present form. The original hewn sills and their foundation piers suggest that the original house was an I-house with a central hall, two rooms per floor, and two exterior stone chimneys. Little original fabric remains from this period other than the sills, the lower parts of the chimneys, and one section of beaded weatherboarding preserved within one of the added rooms. A doorway with a transom and sidelights is also preserved, marking the original entrance to the central hall.

The expansions of the nineteenth and twentieth centuries, which corresponded with the growth of the Russell family and the increasing popularity of the house as a boarding house for travelers, encompassed the original house and resulted in the present two-story frame house with its two-tiered porch on the front (west elevation), two-story rear wing, large stone chimneys, and numerous outbuildings.

Around 1890 the first major expansion was a two-story addition on the front, which included a two-tiered porch, and a two-story coachroom/dining wing on the rear. The coachroom space was added to provide lodging for the growing numbers of travelers. A one-story bath addition was constructed at the intersection of the main block and the coachroom/dining wing in the twentieth century.

The present plan of the house is an expanded central-hall, with four rooms on the first and second stories of the main block. A two-tiered porch on the rear addition provides access to two rooms on each story. The original two rooms and central hall on the first floor survive as the two rear rooms of the main block. The expanded house is sheathed in unbeaded weatherboard.

The Russell house facade, as expanded, is three bays wide with a central door on each level of the two-tiered porch. Chamfered wooden posts, with simple balustrades, enclose each level of the porch. The east elevation includes the stone chimney, with the two windows of the original house flanking it on the first floor. Two other windows, for the front rooms of the expanded house, are on the first and second floors. The rear wing includes the kitchen and the dining room, which open onto a small porch. A stair from the porch leads to the second story. The west elevation repeats the fenestration of the east elevation. Three windows light the dining room and kitchen.

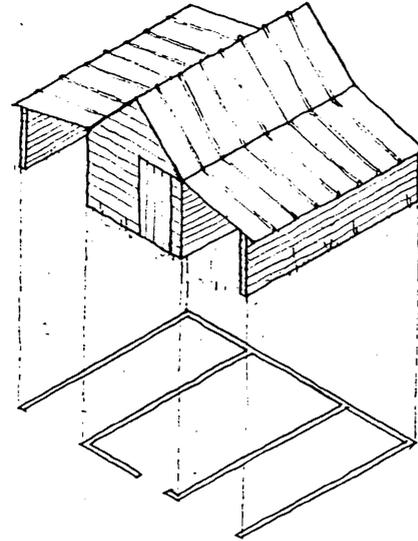
Mini - Barn

- a barnam sized barn scaled down for smaller animals and storage.

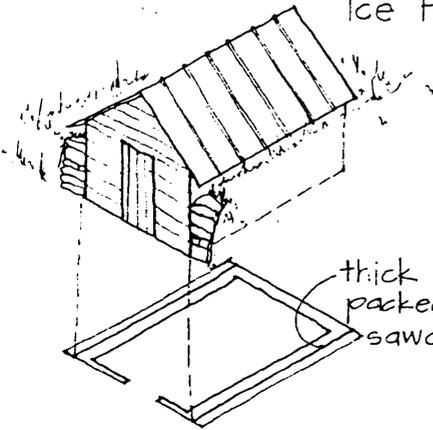
Ice House

thick log walls packed with sawdust

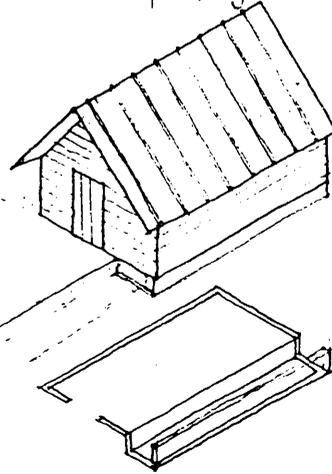
Springhouse

spring

- Storage space for meats, milk, eggs, etc.
- continuous cooling by fresh spring water

A spring house is located about 75 feet north of the house. The spring has rock walls that form a sitting surface about 20 feet long and channels the water into the spring house, which is about 6 by 14 feet. Both spring and spring house are in good condition and are in a very attractive setting beneath very large white pines.
