National Register of Historic Places  
Registration Form

historic name Clarkson Farm Complex  
other names/site number \_\_\_\_\_

street & number U.S. Hwy. 52, 1 1/2 miles S of intersection w/ U.S. 521  not for publication  
city, town Greeleyville  vicinity  
state South Carolina code 045 county Williamsburg code 089 zip code 29056

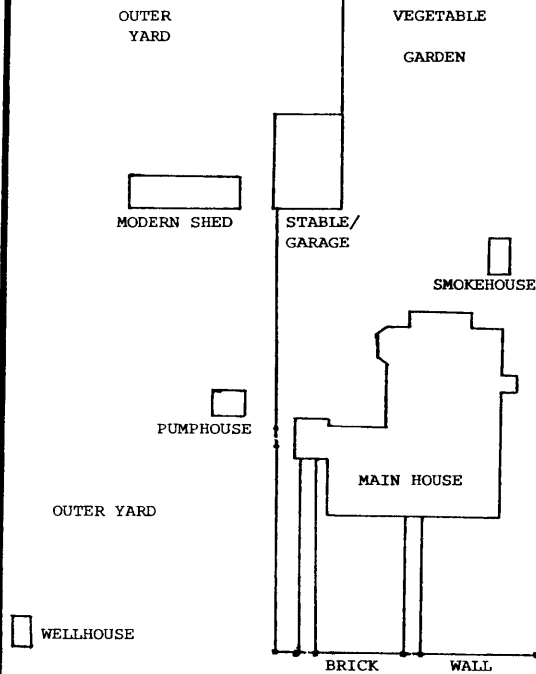
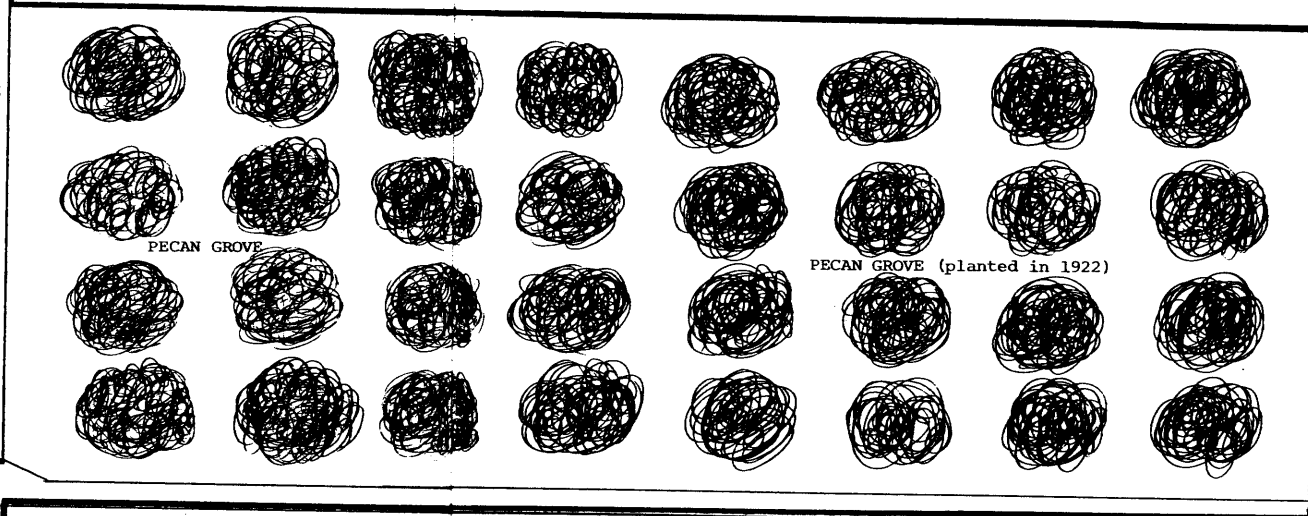
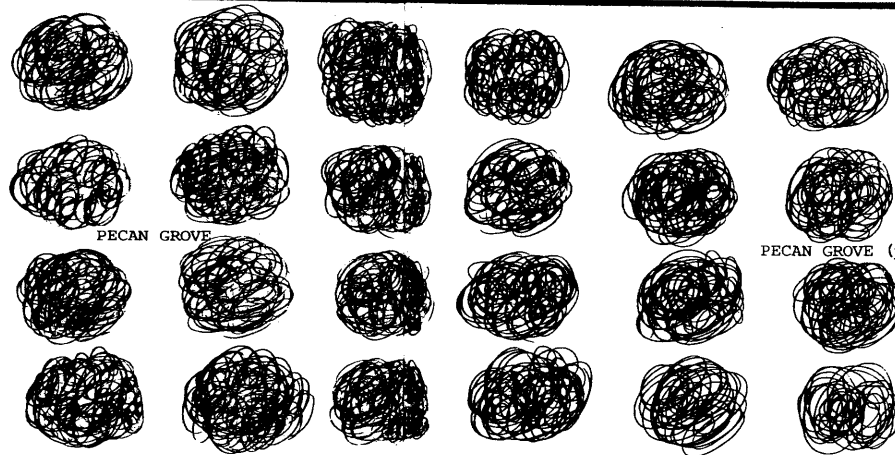
CLARKSON FARM COMPLEX  
WILLIAMSBURG COUNTY, S. C.  
NOT TO SCALE

The Clarkson Farm Complex is located on U.S. Highway 52 approximately one and a half miles south of its intersection with U.S. Highway 521 in the Heineman community of Williamsburg County. The complex consists of the Clarkson residence and six outbuildings. The main house and three of the out-buildings (a smokehouse, a pumphouse, and a stable/garage) are on the east side of the highway; the other three outbuildings (a store, a garage, and a tenant house) are on the west side of the highway.
